FIELD NOTES SUMMARY

Customer: Town of Arlington / Friends of Menotomy Rocks Park (Hills Pond)

Site Location: Arlington, MA

Date: 9/6/22, 12:30 PM

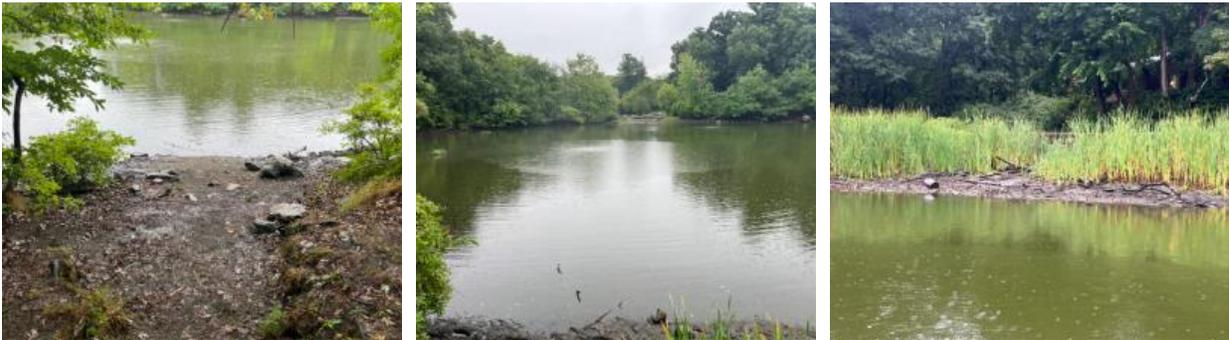
Photos

Upon arrival, a survey was conducted using visual observation paired with a standard throw-rake, as needed. There appeared to be a small microscopic algae bloom within the water column as the water clarity had decreased from the previous site visit. An algae sample was collected and shipped on ice via FedEx overnight to the SePro Lab for analysis of algae identification and enumeration (as directed by David Morgan, Arlington Conservation Agent). Minimal vegetation was documented (primarily duckweed (native) scattered around the shoreline and in the small ponded area).

Prior to the visit, Friends of Menotomy Rocks Park asked us to check on the Vertex aeration system as one of the diffuser patterns did not appear normal. Upon inspection, it was determined that two diffusers did not appear normal. Each of these diffusers was retrieved from the pond and inspected. As seen in photos 5 & 6 below, these two diffusers were broken, with one plate on each broken off. This is not unusual given the age of the diffusers and the fact that they are plastic, which can get brittle over time. The other two diffusers were working well, including the additional diffuser which was added this Spring. The two broken diffusers were shut down in the cabinet, and the other two diffusers were lowered to allow for even and proper distribution of air. The broken diffusers/lines were dragged to the shoreline near some cattails so that they can be repaired when requested. As discussed when adding the additional diffuser (AquaMaster) earlier this year, we are not a Vertex distributor but can replace the broken diffusers with either AquaMaster or Kasco, and place them in their designated spots. AquaMaster diffusers are \$389 each, or Kasco diffusers are \$321 each, plus \$50 for shipping. We will install for free since we have already brought the lines to the shoreline. Please let us know if you'd like to get this repair going, and we will order the necessary diffusers and/or send over a more formal proposal if required.

Please let us know if you have any questions or would like to proceed with an aeration repair/diffuser replacement.
