Re: Menotomy Rocks Park Pond (Hills Pond), Arlington, MA – 2022 Year End Report

Summary Of 2022 Management Activities

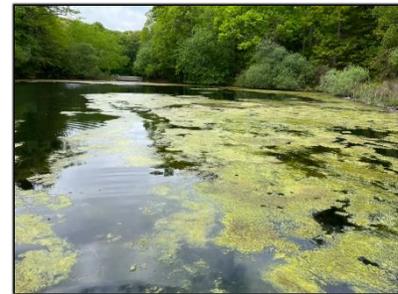
Figure 2: Dense filamentous algae documented within Hills Pond

Upon arrival, a survey was conducted using visual observation. The entire shoreline had dense densities of filamentous algae (see Figures 2 and 3). In addition to the algae, there was moderate densities of curly leaf pondweed (curly-leaf pondweed visible in Figure 2).

As planned, and based on the survey, a treatment was conducted for the control of filamentous algae (illustrated in Figures 2 and 3). Given the condition of the pond during this initial visit, we proceeded with an abundance of caution. To limit the chances of oxygen depletion, from too much biomass die-off at one time, only the algae was targeted during this treatment. The perimeter of the Pond was treated, and the middle was left untreated. The liquid algaecide (Captain XTR), which is copper based, was applied using a treatment boat equipped with a calibrated subsurface injection system, in addition, foliar methodology was used to target areas of floating filamentous algae mats. This application methodology allows for even coverage within the treatment areas. Neon signs noting treatment and no restrictions were posted around the Pond. Arlington Conservation Commission, as well as the Friends of Menotomy Rocks Park were notified of this visit. Given

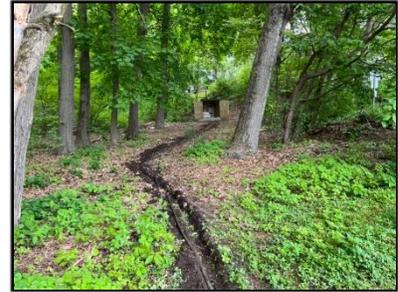
Figure 4: A trench was created from the power box to the shoreline of the Pond for the aeration hosing

Also, while on-site, a fourth diffuser was added to the existing three diffuser aeration system. This was completed without issue, and proper placement was ensured. To distribute the air from the aeration system equally, the third diffuser, closest to the new fourth diffuser, was relocated. The system was also calibrated to insure even airflow to each diffuser (aeration tubing buried within the trench in Figure 4).

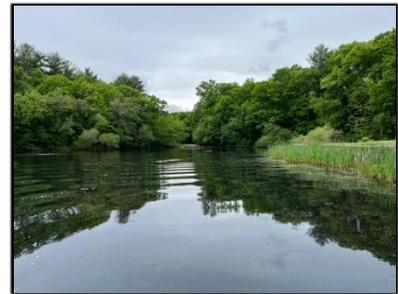
Figure 5: Overlooking Hills Pond post-treatment

Upon arrival, a survey was conducted using visual observation paired with a standard throw-rake, as applicable. The first observation during the survey was the drastic algae reduction following the previous treatment on May 20th (great results from the treatment pictured in Figure 5). Only trace densities of algae were noted along portions of the shoreline, specifically along the northern shoreline. Claspingleaf pondweed (*Potamogeton perfoliatus*) and curly-leaf pondweed were noted in varying densities throughout the Pond, with several areas reaching dense densities. These species were documented growing throughout the water column as well as surfacing. Three water chestnut plants were noted (see Figure 6 to the left), hand-pulled, and disposed of off-site in an approved upland area. The aeration system was inspected and was working properly. The system was inspected and calibrated during the previous visit as the additional diffuser was being installed. Water clarity was above average and much improved from the previous visit.

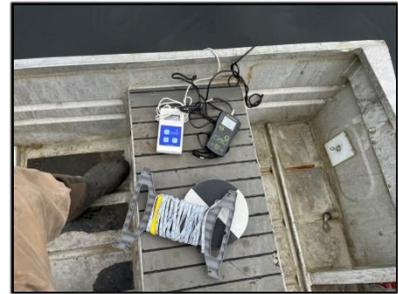
Figure 7: Equipment and meters used during the site visit to collect basic water quality data

While on-site, basic water quality was collected using calibrated meters (pictured in Figure 7 below). The pH was 7.0, which is within a standard range for freshwater and is considered neutral. The water temperature was consistent with other similar waterbodies we

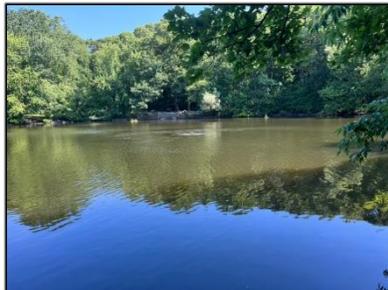
Figure 8: Post-treatment survey conducted at Hills Pond

Upon arrival, a survey was conducted using visual observation. There was no filamentous algae observed throughout the Pond (see Figure 8), and a healthy amount of duckweed (*Lemnoideae*), a native species, was seen along the shoreline. In addition, bryozoans, which are the jelly-like blobs floating in the water (made up of tiny invertebrates), were noted. These bryozoans indicate that the Pond was clean and healthy, and they are generally a sign of good water quality. They are not harmful. The aeration system was inspected and was running properly.

Based on the survey, no treatment was necessary. By providing regular monitoring visits, it allows us to treat only when necessary. This limits over-treating or under-treating. Overall, the Pond looked excellent (illustrated in Figure 8).

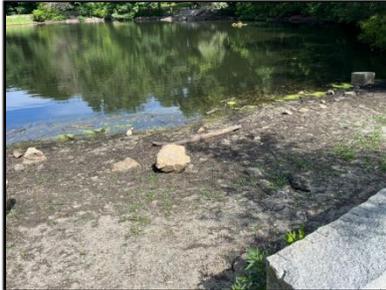
Figure 9: Very low water levels within Hills Pond

Upon arrival, a survey was conducted using visual observation paired with a standard throw-rake, as applicable. The first noticeable observation while on site was that the water level was very low (low water levels pictured in Figure 9 to the left). There is now a significant berm of land between the Pond and the northwestern wetland basin. Overall, the Pond looked great as no nuisance plant or algae growth was observed. There was a small microscopic algae bloom occurring, however it was very minor and did not appear to be concerning. This was visible within the water column and on the surface of the water, especially within the windblown shorelines. Cattails (*Typha sp.*) were noted growing along the northern/northwestern shoreline. The aeration system was inspected and was running per normal. Plants were documented flowering within the vegetation islands. Duckweed was documented within the wetland basin area, as well as scattered in healthy densities around the shoreline. We were unsure as to whether or not the Health Agent mistook this lime green color for possible cyanobacteria. It is best seen scattered around the shoreline and appears concerning from afar, but upon inspection it was just duckweed.

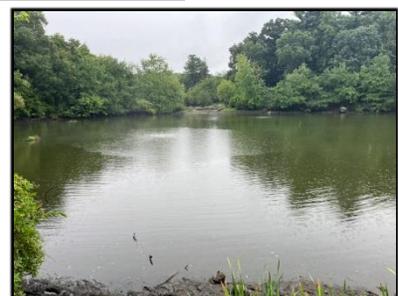
Figure 10: Small microscopic algae bloom visible throughout the Pond

Upon arrival, a survey was conducted using visual observation paired with a standard throw-rake, as needed. There appeared to be a small, microscopic algae bloom within the water column as the water clarity had decreased from the previous site visit (see Figure 10). An algae sample was collected and shipped on ice via FedEx overnight to the SePro Lab for analysis of algae identification and enumeration (as directed by David Morgan, Arlington Conservation Agent). Minimal vegetation was documented (primarily duckweed scattered around the shoreline and in the small, ponded area).

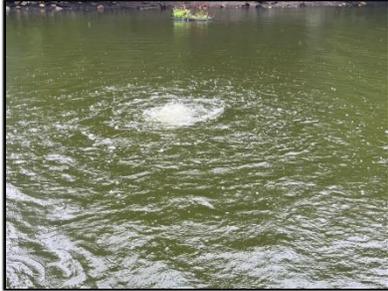
Figure 11: Aeration diffuser not working properly

Prior to the visit, Friends of Menotomy Rocks Park asked Water and Wetland to check on the Vertex aeration system as one of the diffuser patterns did not appear normal (aeration diffuser not properly running in Figure 11). Upon inspection, it was determined that two diffusers did not appear normal. Each of these diffusers was retrieved from the Pond and inspected. Upon inspections, two diffusers were broken, with one plate on each broken off (see Figure 12 below). This is not unusual given the age of the diffusers and the fact that they are plastic, which can get brittle over time. The other two diffusers were working well, including the additional diffuser which was added this Spring. The two broken diffusers were shut down in the cabinet, and the other two diffusers were lowered to allow for even and proper distribution of air. The broken diffusers/lines were dragged to the shoreline near some cattails so that they can be repaired when requested. As discussed, when adding the additional diffuser (AquaMaster) earlier this year, we are not a Vertex distributor but can replace the broken diffusers with either AquaMaster or Kasco and place them in their designated spots.
