FIELD NOTES SUMMARY

Customer: Town of Arlington
Pond Name: Hill's Pond
Site Location: Arlington, MA
Date: 9/18/24

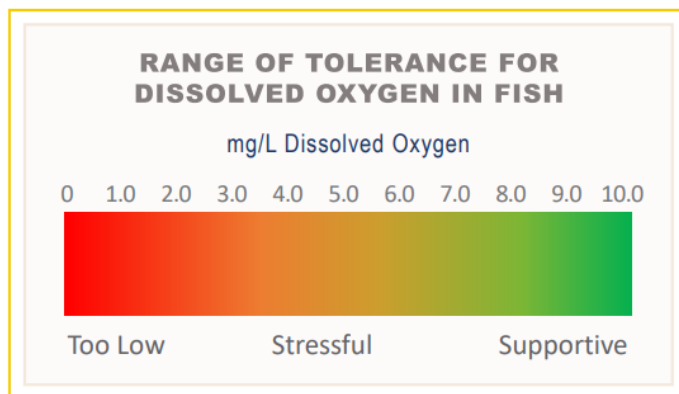
While on-site, dissolved oxygen (DO) and temperature readings were collected using a calibrated YSI meter with optical sensor. Dissolved oxygen is the amount of oxygen in water that is available to aquatic organisms. DO is necessary to support fish spawning, growth, and activity. Tolerance varies by species, but the figure below provides a general range of fish tolerance (Source: epa.gov). Dissolved oxygen can be affected by

many outside factors, such as: temperature, time of day, and pollution. Dissolved oxygen levels are typically lowest early in the morning. Healthy water should generally have concentrations of about 6.5-8+ mg/L.
