FIELD NOTES SUMMARY

Customer: Town of Arlington Pond Name: Hill's Pond Site Location: Arlington, MA

Date: 5/13/24

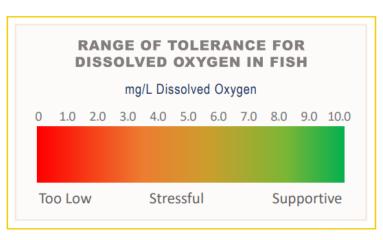
While on-site, dissolved oxygen (DO) and temperature readings were collected using a calibrated YSI meter with optical sensor. Dissolved oxygen is the amount of oxygen in water that is available to aquatic organisms. DO is necessary to support fish spawning, growth, and activity. Tolerance varies by species, but the figure below provides a general range of fish tolerance (Source: epa.gov). Dissolved oxygen can be affected by

many outside factors, such as: temperature, time of day, and pollution. Dissolved oxygen levels are typically lowest early in the morning. Healthy water should generally have concentrations of about 6.5-8+ mg/L.
